Evaluation Of Candidate Alloys For The Construction Of Metal Flex Hoses In The STS Launch Environment

DOCUMENT NO. MTB-325-87A
DATE: AUGUST 23, 1988

TEST REPORT

National Aeronautics and Space Administration
Kennedy Space Center
Materials Testing Branch

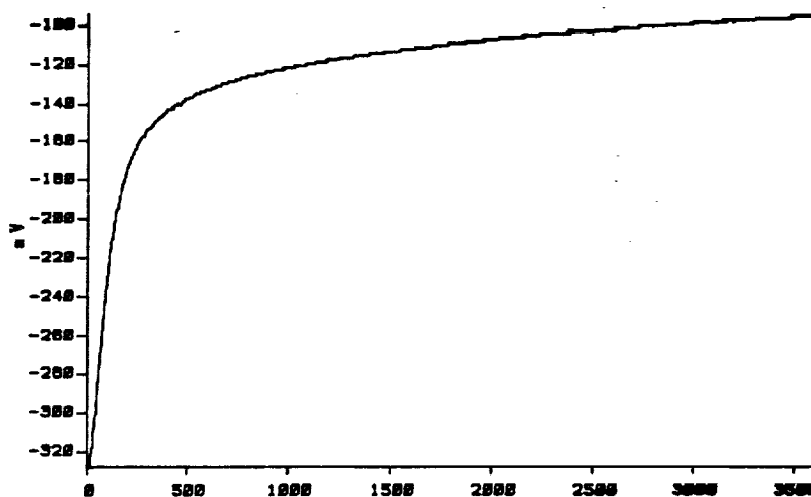
Figure 1 Stable Corrosion Potential

ES 2205 in Aerated 3.55% NaCl - 0.1N HCl
Corrosion Potential (mV) vs Time (seconds)

- 4.1.2 Corrosion potential (E_{corr}) gives an indication of how noble an alloy is in a given environment. Generally, a less negative corrosion potential means that the alloy can be expected to be more resistant to corrosion, in that particular electrolyte, compared to an alloy with a more negative corrosion potential. Thus, alloys can be ranked according to resistance to general corrosion, based on corrosion potential. Figure 1 shows the corrosion potential vs time data for a stable material. Some materials displayed very unstable corrosion potentials, such as shown in Figure 2. Table 5 shows the results for the 19 alloys tested, in order of increasing activity. The potentials are all with respect to the SCE reference and were recorded after 1 hour.

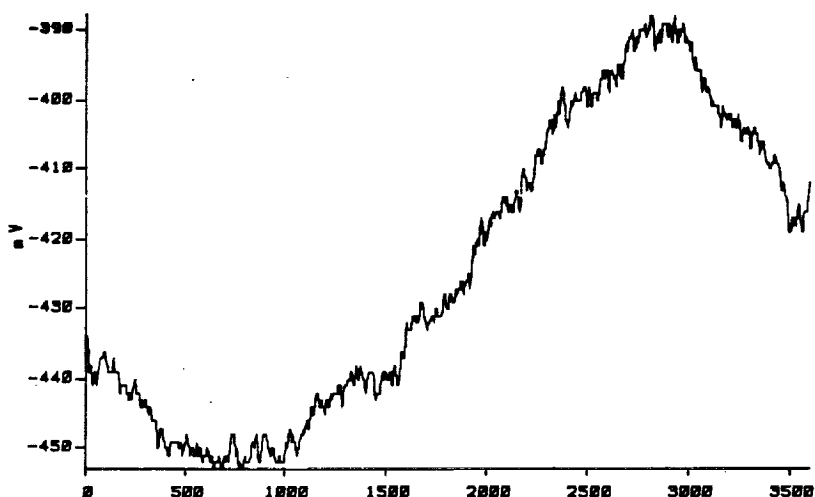
Figure 2 Unstable Corrosion Potential
304LN in Aerated 3.55% NaCl - 0.1N HCl
Corrosion Potential (mV) vs Time (seconds)

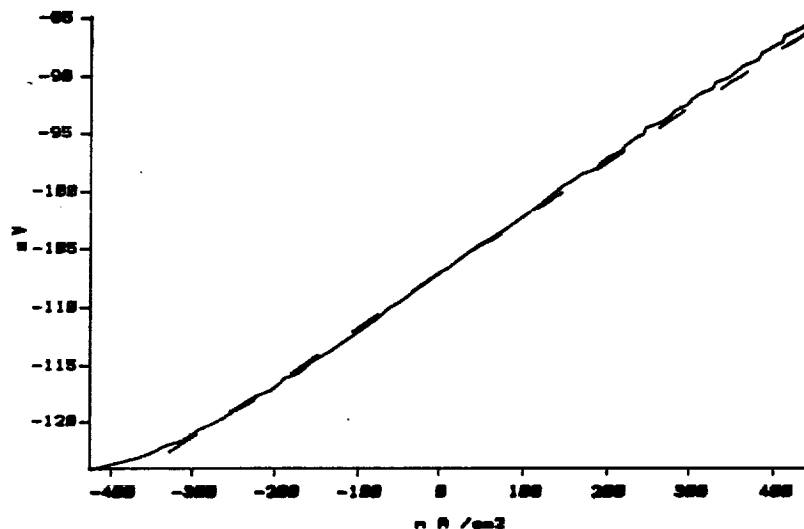
Figure 3 Polarization Resistance Graph
Hastelloy C-4 in Aerated 3.55% NaCl - 0.1N HCl
Potential (mV) vs Current Density (nA/cm²)

- 4.1.3 Polarization resistance is used to calculate the uniform corrosion rate when the potential is close to the corrosion potential. Results of a typical polarization resistance run are shown in Figure 3.

According to the Stearn-Geary theory (23), a graph of E vs I should be linear over a current and potential range very close to $I=0$ (i.e., close to E_{corr}). The slope of this line is R_p in ohms. Corrosion current and uniform corrosion rate are then calculated as follows

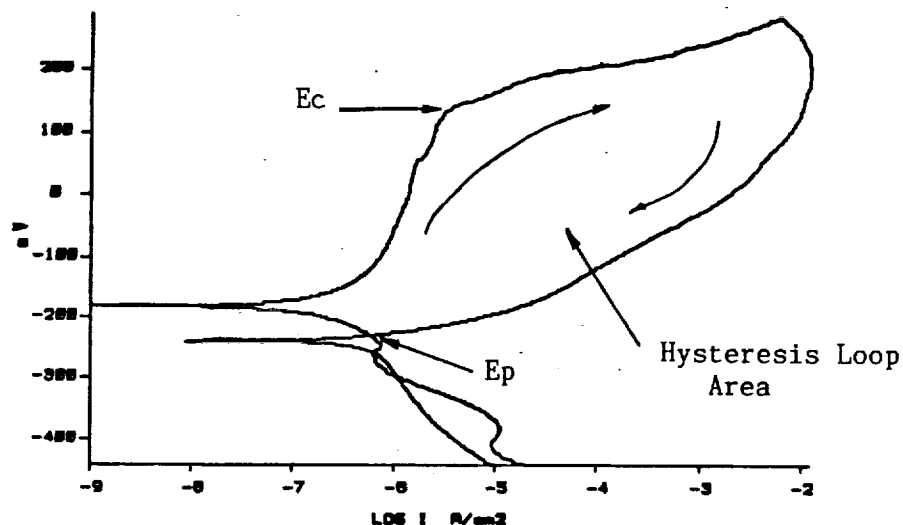
Figure 4 Cyclic Polarization With Hysteresis Loop
316 L in Aerated 3.55% NaCl - 0.1N HCl, mV vs log I (A/cm²)

- 4.1.4 Cyclic polarization gives an indication of a specimen's resistance to pitting corrosion (18,24), and this method has been used for many systems to determine susceptibility to localized corrosion (4-6,9,11,13,16,18,24, 25). Figure 4 shows a curve with the hysteresis effect typical of a material with a low resistance to pitting. Since the potential scan is at a known constant rate,

the potential values can be converted to time, and the area inside the hysteresis loop can be found by integration to give units of coulombs/cm². This area value should be very small for alloys that are highly resistant to pitting, as seen in Figure 5 which is for a material that is very corrosion resistant. In this case, the reverse scan traces almost exactly over the forward scan.

Two other parameters that apply to cyclic polarization are critical pitting potential (E_c) and protection potential (E_p). At E_c , the current increases dramatically until the reversal point is reached (see Figure 4). The more noble (positive) the value of E_c , the more resistant is the alloy to initiation of localized corrosion. E_p is the point at which the reverse scan intersects the forward scan (see Figure 4). E_p represents repassivation of previously formed pits. In general, localized corrosion can propagate at potentials more noble (positive) than E_p . So, it would be desirable for E_p to be greater than E_{corr} to make it less likely that E_{corr} will exceed E_p , and therefore less likely that localized corrosion will continue. Tables 8 and 9 rank the alloys according to E_c and E_p , respectively.

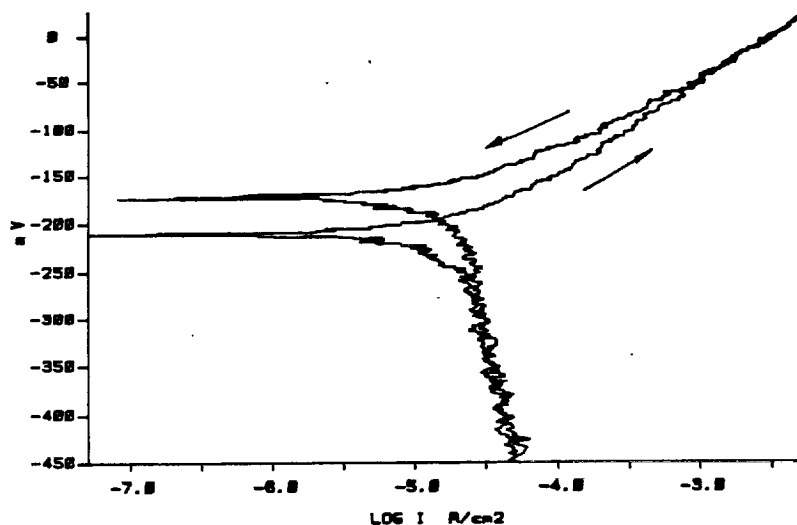
Figure 6 Cyclic Polarization With Uniform Corrosion
Monel 400 in Aerated 3.55% NaCl - 0.1N HCl
Potential (mV) vs Log Current Density (A/cm^2)

- 4.1.5 Some alloys displayed uniform corrosion, rather than localized pitting or crevice corrosion. This was the case for Monel 400 and Hastelloy B-2. In these instances, the cyclic polarization curves were similar to the one shown in Figure 6. This type of curve does not yield meaningful values for E_c, E_p, or area of the hysteresis loop. Therefore, data for these two alloys do not appear in Tables 7, 8, and 9. Although these two alloys did not suffer localized

corrosion, they did have an unacceptably high uniform corrosion rate, as seen in Table 6.

4.1.10 The cyclic polarization results for the stronger electrolyte are summarized in Table 13, with the alloys ranked according to weight loss. The 304L sample experienced uniform corrosion. Therefore, results for 304L do not appear in Table 13, for the reasons mentioned in paragraph 4.1.5 in regard to Figure 6 (i.e., no meaningful values for E_c , E_p , or area).

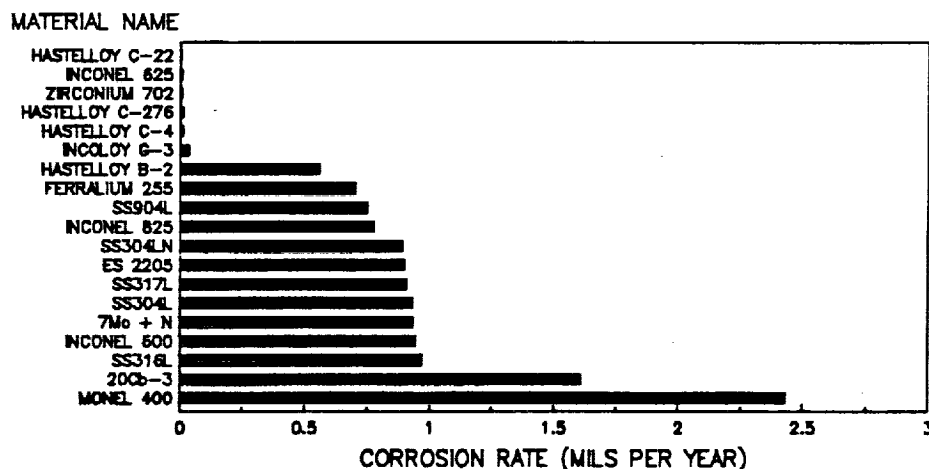
FIGURE 8 - SALT FOG/ACID DIP DATA
20 WEEKS/20 ACID DIPS

When the corrosion rate data is graphed, as in Figure 8, the great differences in performance can easily be seen. The level of performance of the top alloys is much higher than that of the lower materials. The cutoff line between the Incoloy G-3 and the Hastelloy B-2 shows a 15 fold increase in the corrosion rate. The corrosion rate of 304L stainless steel is approximately 260 times higher than that of Hastelloy C-22 in the salt fog/acid dip exposure test. The slight weight gains for Hastelloy C-22 and Inconel 625 in weeks 16 and 20 were unexpected. This could have been caused by slight errors in measurement or differences in cleaning and weighing procedures. However, this did not upset the relative rankings, and the gains were considered insignificant.

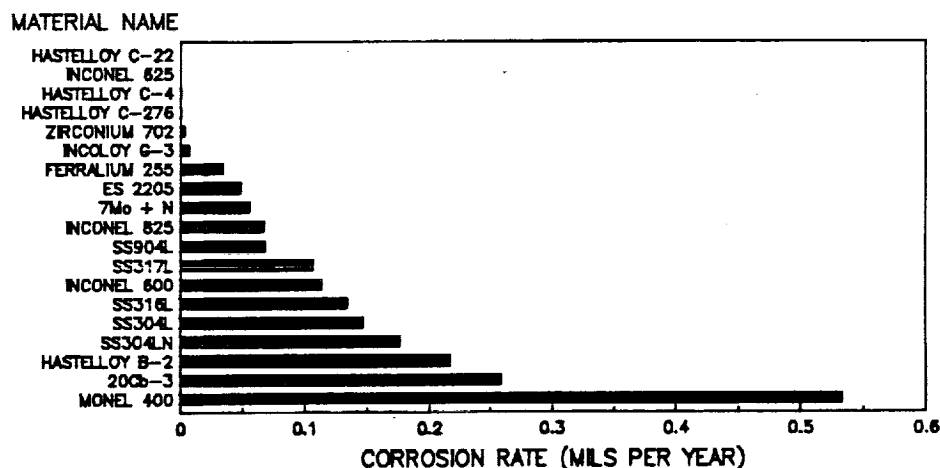
FIGURE 9 - BEACH CORROSION DATA
251 DAYS/13 ACID SPRAYS

- 4.3.3 When the beach results are compared to the salt fog results, many materials change positions relative to each other. In general, the materials at the top (Hastelloy C-22 and Inconel 625) and at the bottom (20Cb-3 and Monel 400) of each list remained in their respective positions. However, the standard stainless steel alloys such as 304L, 304LN, 316L, and 317L declined in relative performance while the duplex stainless alloys such as Ferralium 255, 7Mo+N, and ES 2205 improved in the rankings. This was an interesting occurrence and could be explained as follows. The main difference between the two tests is oxygen availability. While the specimens are in the salt fog chamber, the surfaces are continually wet, and this film of water could reduce the oxygen available to the metal surface. Since most corrosion resistant alloys depend on oxide films on their surface for protection, the suspicion is that the salt fog conditions could be hindering the formation of these protective oxide films on the duplex stainless steels, allowing accelerated corrosion to take place. The beach data, in contrast to the salt fog data, supports the electrochemical findings in regard to the Ferralium 255. The reasons for this are unclear but could be due to the formation of the protective oxide films.

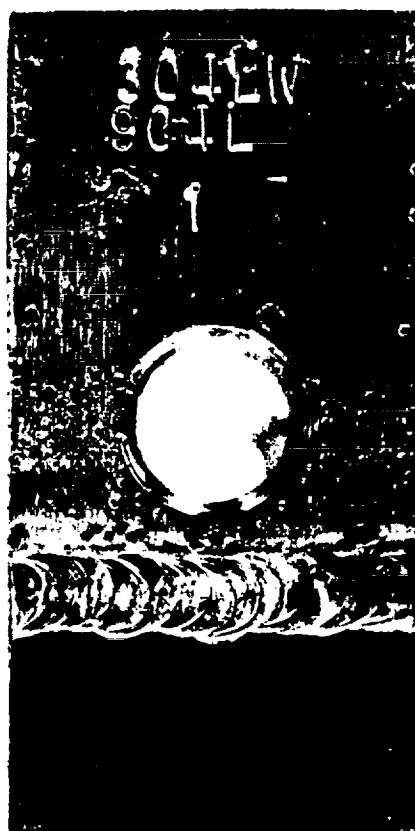
b) 304L Welded to 904L

<--- 304L
Severe Pitting

<--- 904L
No Corrosion

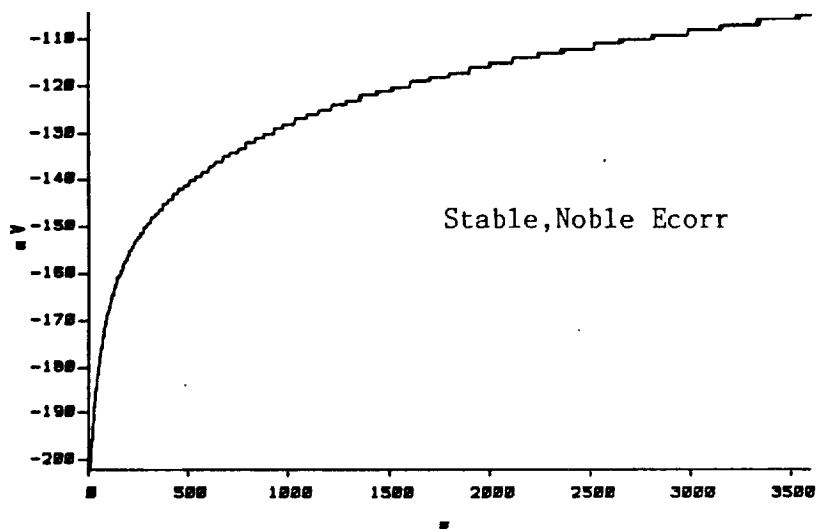
Figure A1 Hastelloy C-4 Corrosion Potential
in Aerated 3.55% NaCl + 0.1N HCl

- 4.1.11 The graphical results for corrosion potential and cyclic polarization for each of the alloys are shown in Appendix A, Figures A1 to A58. Graphs are included for the 3.55% NaCl + 0.1N HCl electrolyte for all of the alloys. For the more resistant alloys, the graphs from the 3.55% NaCl + 1.0N HCl electrolyte are also given. All of these results are summarized and briefly explained in Table 14.

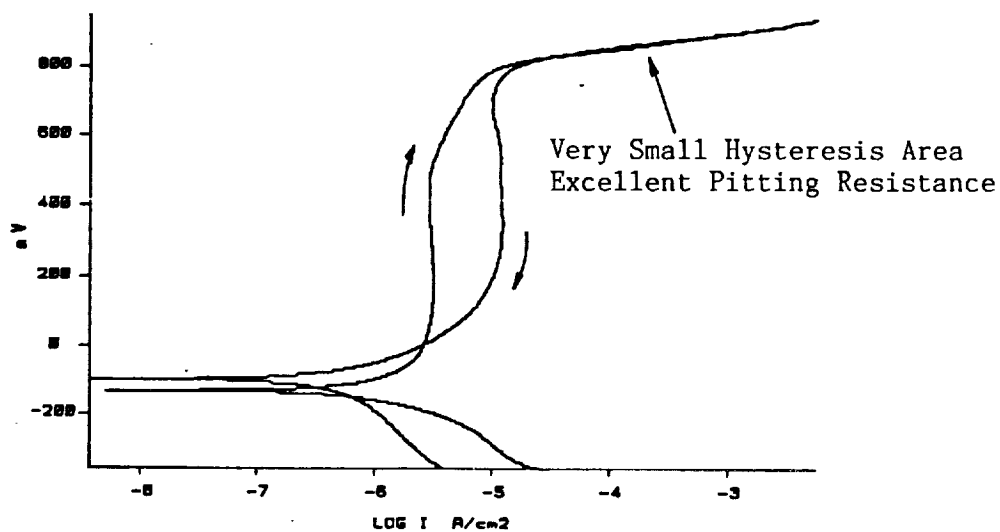
Figure A2 Hastelloy C-4 Cyclic Polarization
in Aerated 3.55% NaCl + 0.1N HCl

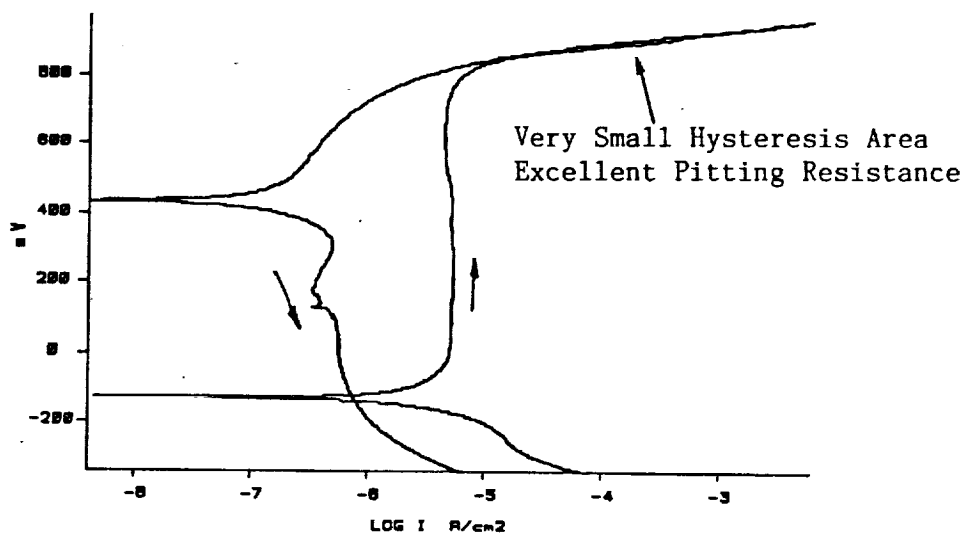
Figure A4 Hastelloy C-4 Cyclic Polarization
in Aerated 3.55% NaCl + 1.0N HCl

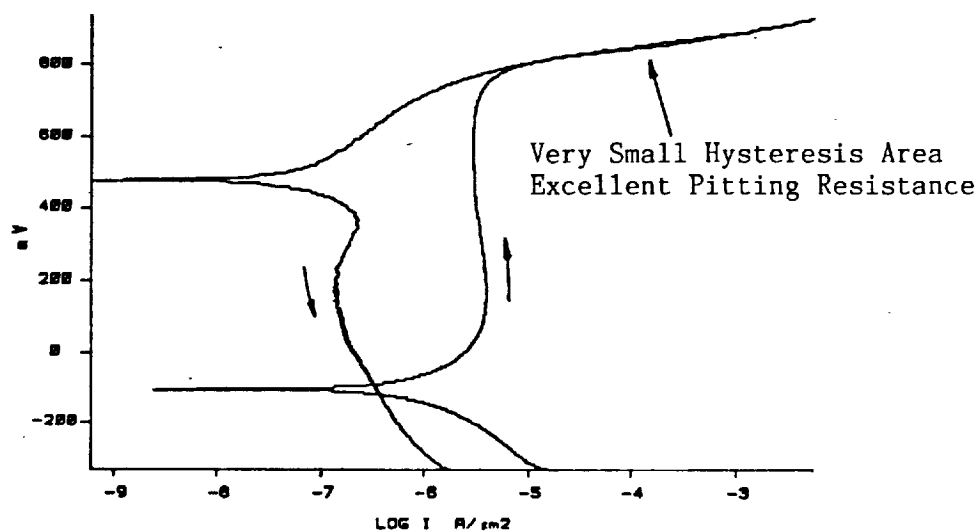
Figure A10 Hastelloy C-276 Cyclic Polarization
in Aerated 3.55% NaCl + 0.1N HCl

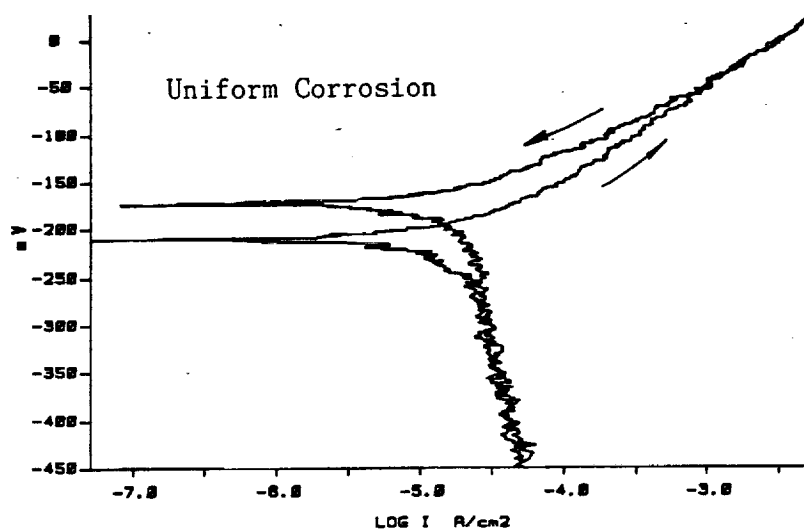
Figure A28 Monel 400 Cyclic Polarization
in Aerated 3.55% NaCl + 0.1N HCl

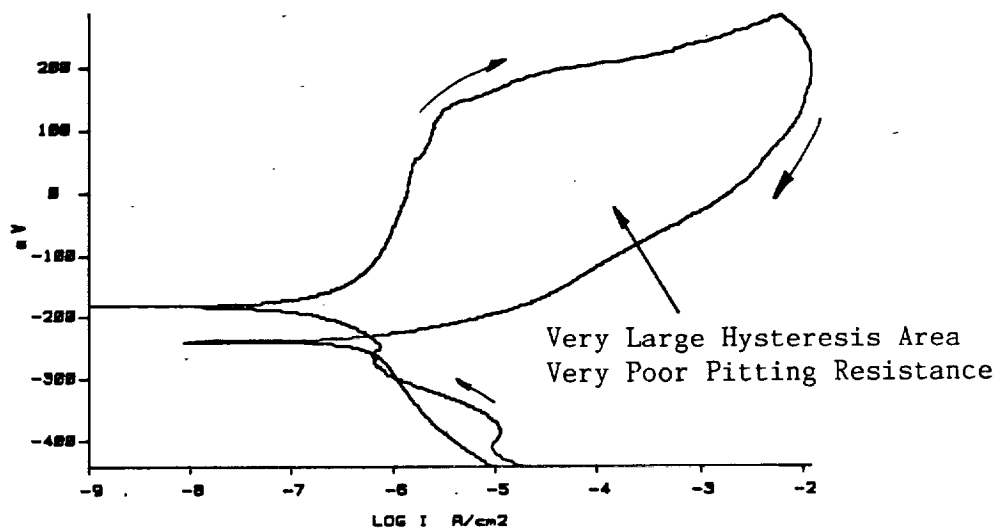
Figure A38 316L Cyclic Polarization
in Aerated 3.55% NaCl + 0.1N HCl
